TROUBLESHOOTING & MAINTENANCE

Rev 05/11 Form No. TM25.101

Model 20, 25 & 27 Freezeless Wall Faucet

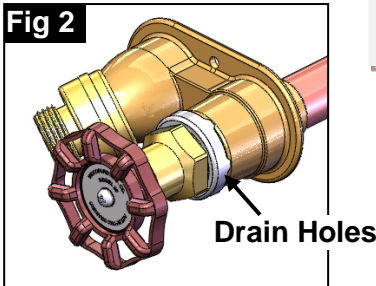
Fig 2

Drain Holes

- **Water leaks from the drain holes, behind the handle, when the faucet is full on and flowing water from the nozzle. (Fig 2)**
The **Drain Valve** (35280) is damaged and needs to be replaced. Follow instructions below on how to remove the operating rod and replace the drain valve. (Fig 4)

- **Water leaks from the drain holes, behind the handle, when the faucet is only partially open with either a trickle of water from the nozzle or before water flows from the nozzle. (Fig 2)** The **Plunger** (30230) is undersize or damaged. Follow instructions below on how to remove the rod and replace the plunger. (Fig 4)

- **Faucet leaks from the nozzle or leaks from the drain holes when the faucet is off. (Fig 2)** If it's a new installation, most likely caused by debris or obstruction in the seat. Follow instructions below on how to remove the operating rod and inspect plunger for damage and flush the casing before reassembling.

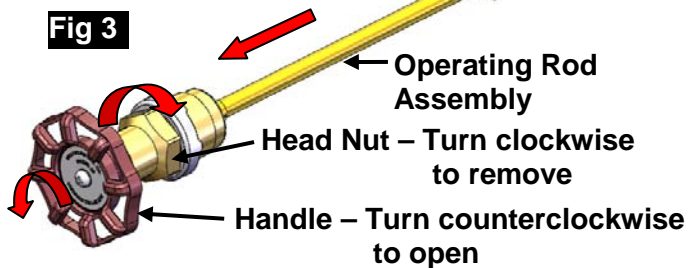
Fig 3

Operating Rod
Assembly

Head Nut – Turn clockwise
to remove

Handle – Turn counterclockwise
to open

- **Operating rod removal. (Fig 3)** To remove the **Operating Rod** from the faucet, shut off the water supply to the faucet and turn the **Handle** counterclockwise to the full open position. Remove the **Head Nut** with a wrench by turning clockwise (left hand threads). Pull the operating rod assembly out of the faucet. The plunger and drain valve are threaded on the rod. A couple pairs of vise grips will remove the parts from the rod. When reassembling the parts on the rod, do not over tighten or the rod may break at the threads.

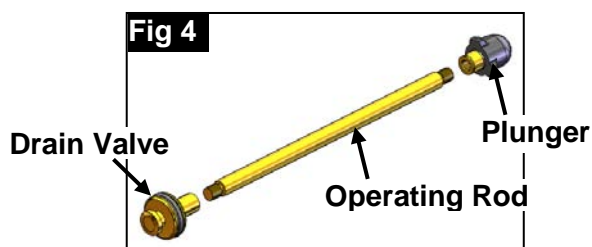
Fig 4

Drain Valve

Operating Rod

Plunger

- **Faucet makes a loud squealing noise when the faucet is on.** Caused by excessive water pressure from the supply line (125 PSI or greater). A new **Plunger** (30230) (Fig 4) may solve the problem, but a pressure regulator on the supply line may be required.
