TROUBLESHOOTING & MAINTENANCE

WOODFORD MANUFACTURING COMPANY, LLC

Utility Yard Hydrant Lever Handle Models

Operating Pipe Removal (Lever Handle Models)

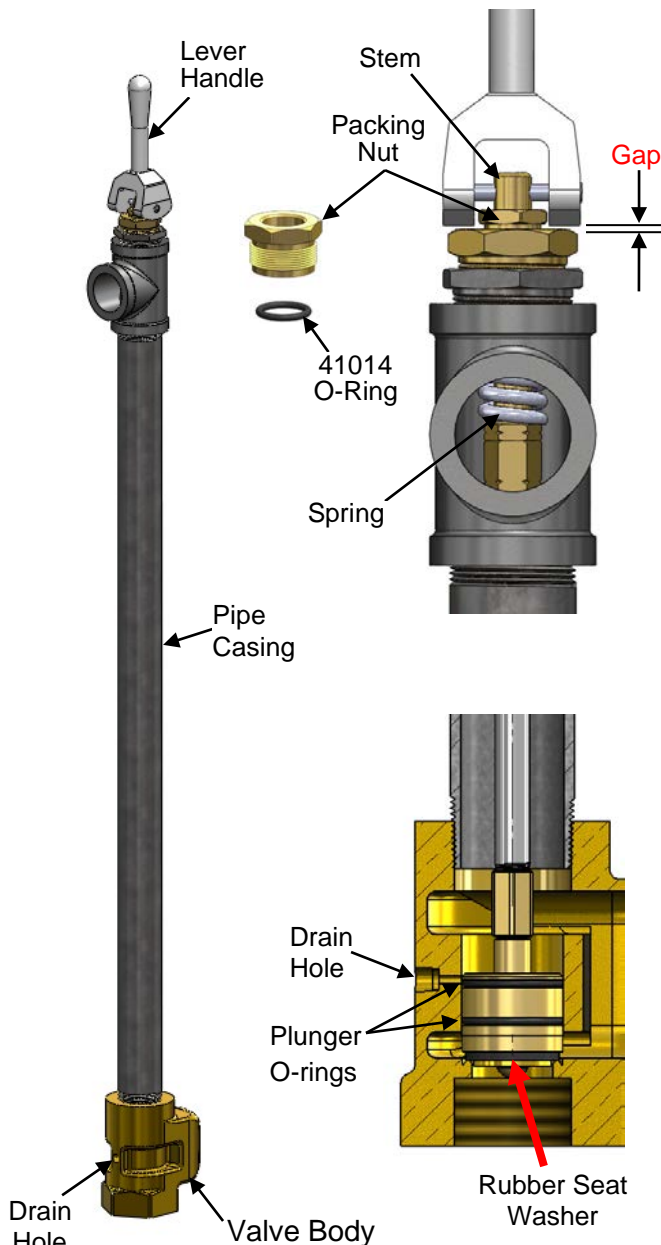
Water leaks from the outlet when the hydrant is off.

- Lever handle hydrants require a 1/16" – 1/8" **Gap** between the handle and surface the handle rides. If there is no gap and the handle does not have any play, it can leak. Tighten nut under handle to achieve a gap.
- Lever handle hydrants use a spring tension to seat the rubber. Excessive supply pressure can cause the hydrant to leak.
- The rubber Valve Seat Washer may be worn or damaged and needs to be replaced. See [Operating Pipe Removal](#) instructions.
- If the hydrant leaks just after installation, the valve seat may be fouled with debris, such as small rocks. The operating pipe assembly will have to be removed and the hydrant casing flushed. See [Operating Pipe Removal](#) instructions.

Packing leak: Water leaks around the brass stem below the linkage when the hydrant is on.

- Utility hydrants use an O-ring to seal the Stem. First make sure the Packing Nut is tight. If the leak continues, the O-ring needs to be replaced. [Order 41014 O-Ring](#)

Hydrant leaks from below ground level when the hydrant is on.

- If the hydrant leaks when full on, the Plunger O-Rings may be damaged and need to be replaced. See [Operating Pipe Removal](#) instructions.
- A large leak may be the result of a hole in the pipe casing caused by electrolysis corrosion. Some soil conditions can cause premature failure of the pipe casing near the valve body.

Hydrant will not drain when shut off.

- Make sure there are no attachments on the outlet, such as a hose or vacuum breaker.
- A poor drain field around the valve body or a blocked

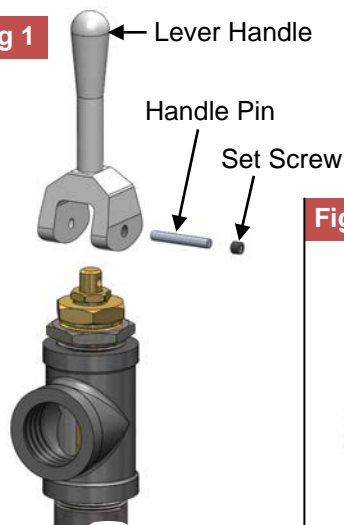
Fig 1

1. Shut off water supply to hydrant.
2. Remove the Set Screw from the side of the Handle and pull the Handle Pin. **Fig 1**
3. Place the Handle Pin back through the hole in the Stem. The Handle Pin in the Stem will keep the Spring from losing its compression and keep the assembly together. **Fig 2**
4. Unthread the largest Nut from the Tee or casting. **Fig 2**
5. Pry the Rod Assembly loose from the Valve Seat and remove the entire Rod Assembly. **Fig 3**
6. Inspect Plunger Rubber, O-rings and Seals for damage. *Plunger Assemblies are available for all Utility Hydrant models.*

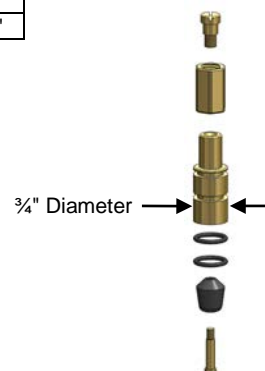
Fig 3

Plunger Assemblies 8 Parts		
Plunger Assembly #	Fits Hydrant Model	Plunger Dia.
41060	U100A/M & U125A/M	1"
41083	U150A/M	1-1/2"
41093	U200A/M	1-13/16"

Plunger Assembly 7 Parts	
Plunger Assembly #	Fits Hydrant Model
41018	U34A/M & U75A/M

Plunger Diameter
See Chart Above

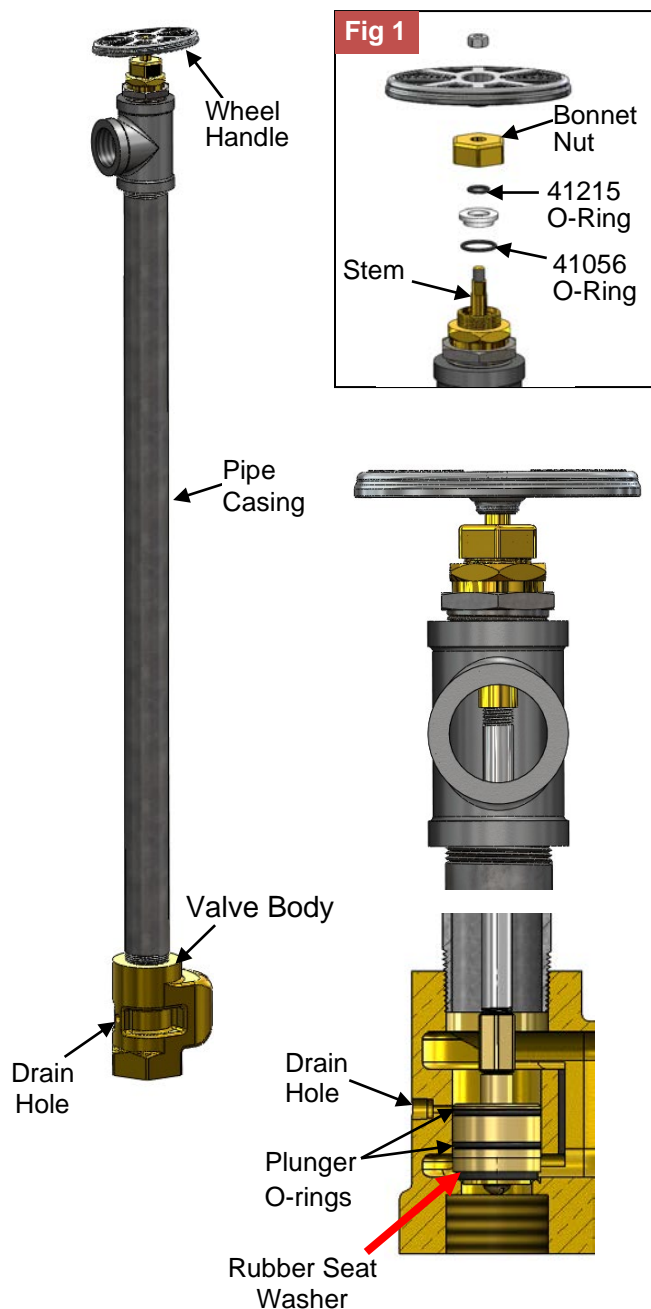
Water leaks from the outlet when the hydrant is off.

- The rubber Valve Seat Washer may be worn or damaged and needs to be replaced. See [Operating Pipe Removal](#) instructions.
- If the hydrant leaks just after installation, the valve seat may be fouled with debris, such as small rocks. The operating pipe assembly will have to be removed and the hydrant casing flushed. See [Operating Pipe Removal](#) instructions.

Packing leak: Water leaks around the brass stem below the linkage when the hydrant is on.

- Utility hydrants use an O-Ring to seal the Stem. First make sure the Bonnet Nut is tight. If the leak continues, the O-Ring needs to be replaced. [Order 41215 O-Ring Fig 1](#)

Hydrant leaks from below ground level when the hydrant is on.

- Wheel handle hydrants must be open more than half way or else they will leak from the drain during use.
- If the hydrant leaks when full on, the Plunger O-Rings may be damaged and need to be replaced. See [Operating Pipe Removal](#) instructions.
- A large leak may be the result of a hole in the pipe casing caused by electrolysis corrosion. Some soil conditions can cause premature failure of the pipe casing near the valve body.

Hydrant will not drain when shut off.

- Make sure there are no attachments on the outlet, such as a hose or vacuum breaker.
- Make sure the hydrant is shut off completely.
- A poor drain field around the valve body or a blocked drain hole will also prevent drainage. See [Yard Hydrant Installation Instructions](#).

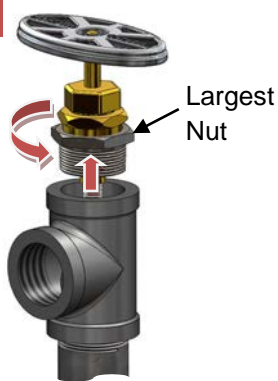
Fig 2

1. Shut off water supply to hydrant.
2. Turn Handle to full open position. **Fig 1**
3. Unthread the largest Nut from the Tee or casting. **Fig 2**
4. Pry the Rod Assembly loose from the Valve Seat and remove the entire Rod Assembly. **Fig 2 & 3**
5. Inspect Plunger Rubber, O-rings and Seals for damage. *Plunger Assemblies are available for all Utility Hydrant models.*

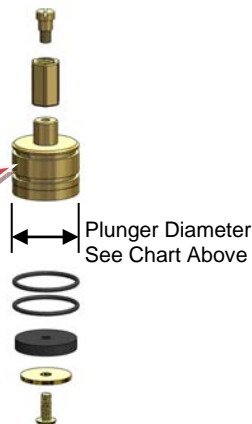
Plunger Assemblies (8 Parts)		
Plunger Assembly #	Fits Hydrant Model	Plunger Dia.
41060	U100W & U125W	1"
41083	U150W	1-1/2"
41093	U200W	1-13/16"
