# TROUBLESHOOTING & MAINTENANCE

### **MODEL 14 WALL FAUCETS**

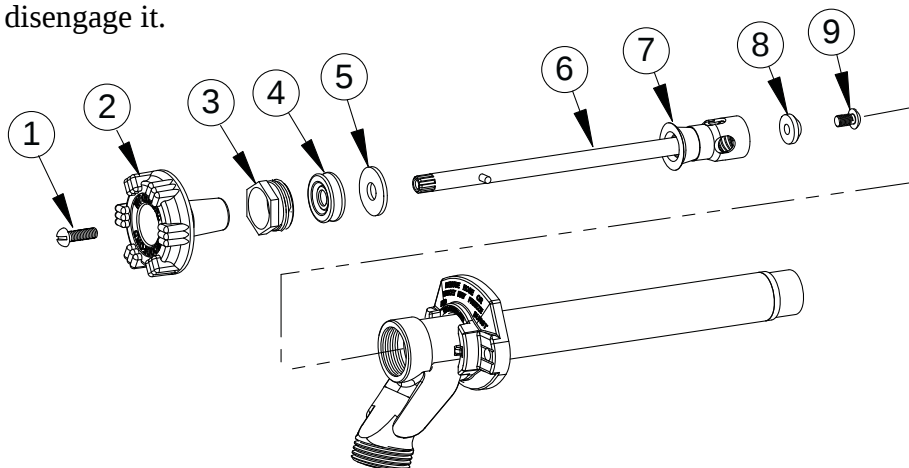
- **Valve Stem Assembly - Operating Rod Removal**  
To remove the operating rod (Items 6-9) from the faucet, shut off the water supply and remove the handle and packing nut (Items 1-3). Use the handle to turn the rod counterclockwise until the rod becomes disengaged from the valve seat. Use a small screwdriver to pry the packing loose (Item 4). Pull the rod out of the faucet. The rod may have a check valve (Item 7) that will add resistance to removal, but a swift pull will disengage it.

- **Faucet will not shut off: Water runs or drips out nozzle when the faucet is off**  
Valve seat rubber (30008 Item 8) is worn or damaged and needs to be replaced or the seat rubber screw is loose. Follow instructions below on how to remove the operating rod. If this does not fix the leak, the faucet may have a damaged seat and the faucet will need to be replaced.

- **Packing leak: Faucet leaks from around the operating stem when it is on**  
The packing nut (Item 3) will occasionally need to be tightened to stop a packing leak. Without removing any parts, tighten the packing nut behind the handle until snug and the leak stops. Persistent leaks will require a new packing ring (30560 Item 4).
