# TROUBLESHOOTING & MAINTENANCE

## R34 Yard Hydrant Packing Replacement

Rev 06/15 Form No. TMYH-1.104

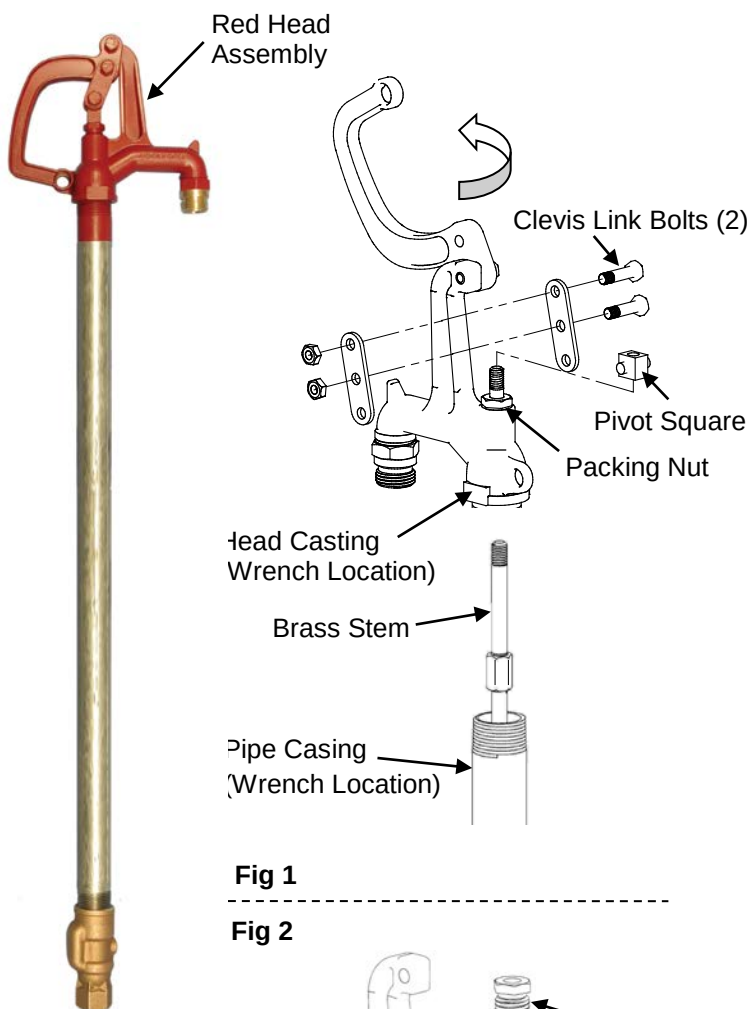
1. Shut off water supply to hydrant.
2. Lift the Handle to the open position. Fig 1
3. Remove the two Link Bolts and rotate handle out of the way. Fig 1
4. Unscrew and remove the Pivot Block. Fig 1

5. Loosen the Packing Nut. Fig 1
6. Remove the head casting using two pipe wrenches, one on head casting and the other on the pipe. Fig 2
7. Remove the Packing Nut. Fig 2
