# TROUBLESHOOTING & MAINTENANCE

## W34 Yard Hydrant Packing Replacement

Rev 06/15 Form No.TMYH-1.104

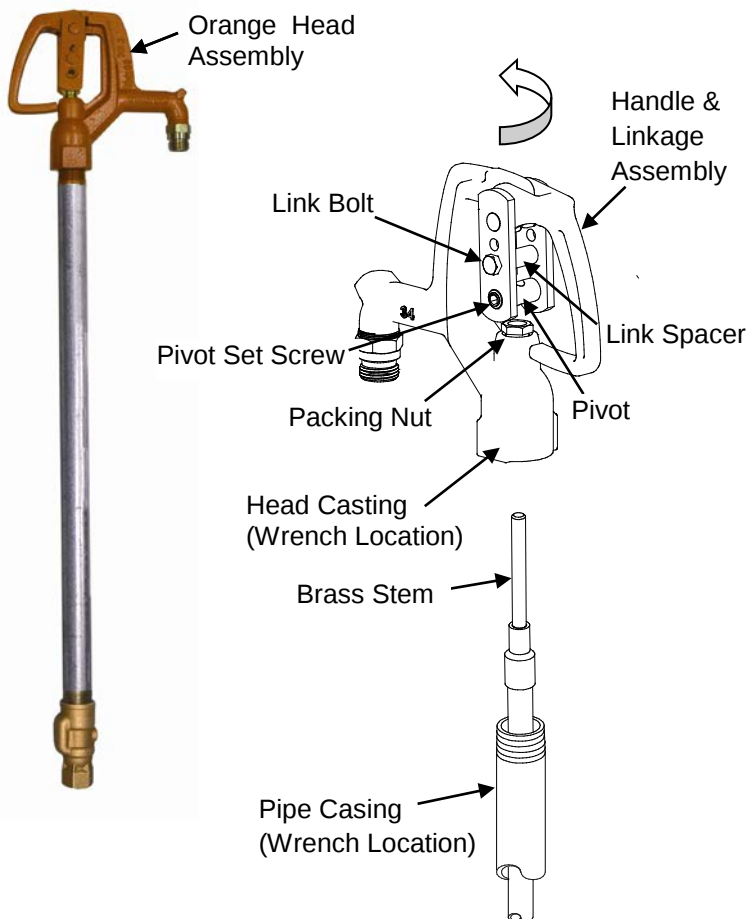
1. Shut off water supply to hydrant.
2. Loosen the Pivot Set Screw. Fig 1
3. Loosen, *do not remove*, the Packing Nut. Fig 1
4. Remove head casting using two pipe wrenches, one on head casting and the other on the pipe. Fig 1

5. Remove the Link Bolt and Link Spacer then remove and set aside the Handle and Linkage Assembly. Fig 1
6. Remove the Packing Nut. Fig 2
7. Dig out the graphite Packing with a screwdriver or other instrument. **Note:** This operation will destroy the Packing and require a new Packing #10101.

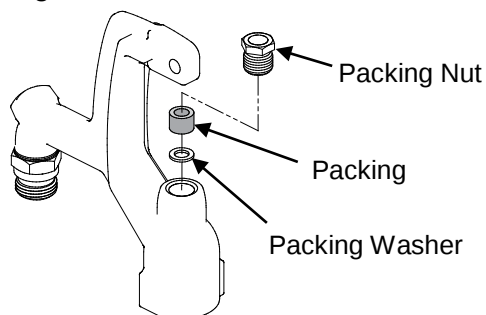
Fig 2

8. The Packing Washer #10102 may be reused.
9. Install new Packing #10101.
10. Reinstall the Packing Nut - *do not tighten*.
11. Reinstall the Handle and Linkage Assembly.
