# TROUBLESHOOTING & MAINTENANCE

## Y34, Y1 or Y2 Yard Hydrant Packing Replacement

Rev 06/15 Form No.TMYH-1.104

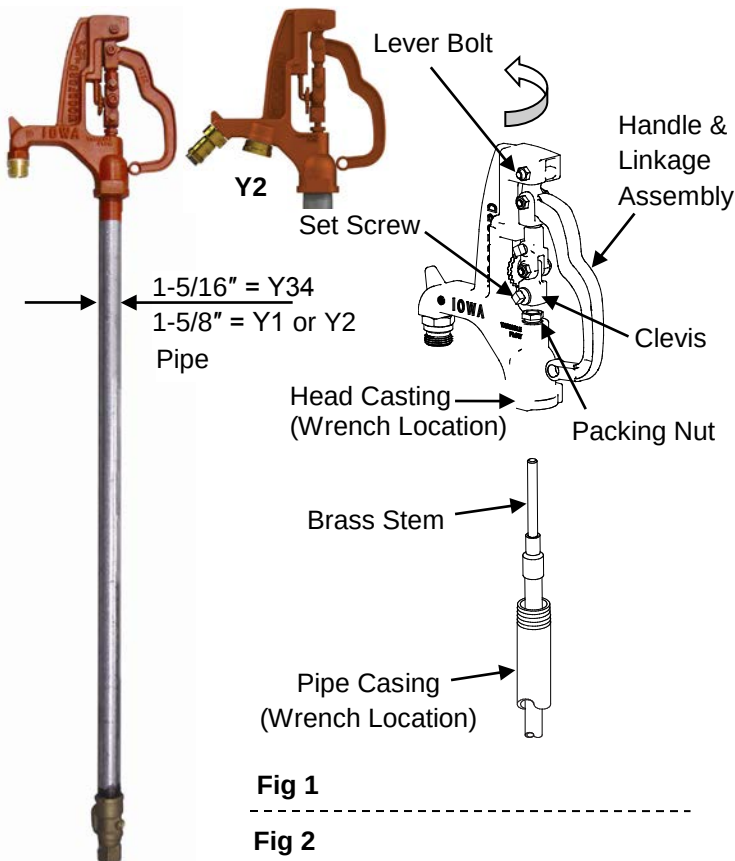
1. Shut off water supply to hydrant.
2. Loosen the Clevis Set Screw. Fig 1
3. Loosen, *do not remove*, the Packing Nut. Fig 1
4. Remove head casting using two pipe wrenches, one on head casting and the other on the pipe. Fig 1

5. Remove the Lever Bolt and remove and set aside the Handle and Linkage Assembly. Fig 1
6. Remove the Packing Nut. Fig 2
7. Dig out the graphite Packing with a screwdriver or other instrument. **Note:** This operation will destroy the Packing and require a new Packing #10101.
