WOODFORD MANUFACTURING COMPANY, LLC.

How a Standard Frost-Proof Faucet Works

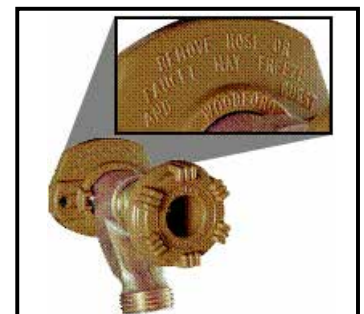
- The warning (left), that the product needs to be installed with a downward pitch, facilitates the draining of the water once the unit is turned off. Also indicated is the warning that the hose must be removed in freezing weather or the faucet may freeze and burst.
- Adjustable wall flange (right) displays **“REMOVE HOSE OR FAUCET MAY FREEZE AND BURST”**

WARNING - Faucet must be installed with downward pitch toward nozzle and hose must be removed in freezing weather or faucet may freeze and burst. Not intended for continuous use applications.
